Facade

Definition: The facade is the front elevation of the building facing the street. Corner buildings often have two principal facades and free-standing public and institutional buildings have multiple facades with the principal one more elaborately treated. The facades usually display finer quality building materials than sides and rears.

Guidelines

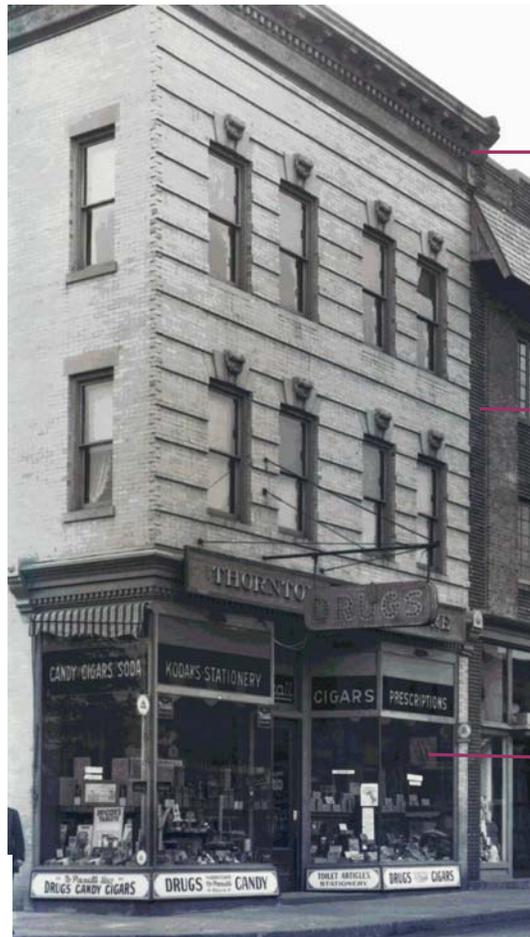
The Thornton Building, 90 East Ridgewood Avenue at southwest corner of Van Neste Square, erected about 1911, photograph circa 1927.

Capping feature: projecting cornice with modillions, dentil band, plain frieze

Middle part: upper masonry wall with regularly organized windows

Lowest part: storefront, mostly glass

The facade of a typical traditional late 19th- early 20th century commercial building in the Village Center Historic District has a three-part horizontal composition:

- The lowest part has the storefront(s) which have large glass display windows and a doorway frequently with enframing piers and a storefront frieze and cornice. Larger buildings may have several storefronts. The visual openness of the storefront is a key element in the overall character of the facade.
- The middle part is usually brick, stucco, stone, or concrete and typically has regularly spaced window openings. If the building has only one story this part is absent.
- The building is terminated by capping features, usually a horizontally-oriented section composed of a frieze, cornice, brackets, parapet, or pent roof, often in combination. On many buildings in the District the roof is hidden behind this terminating section.

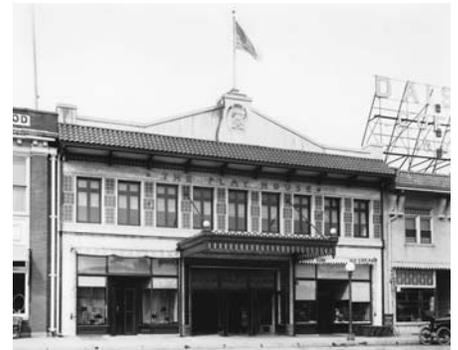
This photograph of the Playhouse at 12-16 Wilsey Square shows its facade as built in 1913 to the designs of the architectural firm Davis, McGrath and Kiessling.

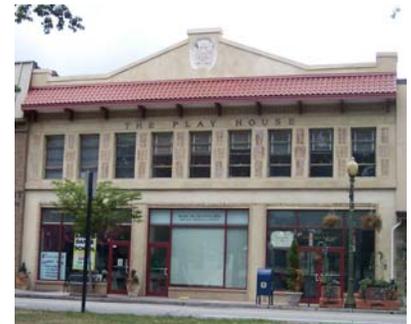
Recommended: Installing compatible contemporary features when original features are gone. The façade underwent numerous changes before it was rehabilitated with some original features preserved and others replicated. The storefronts received a visually compatible contemporary treatment with the unity of the building maintained.

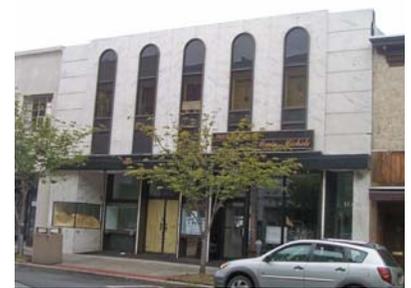
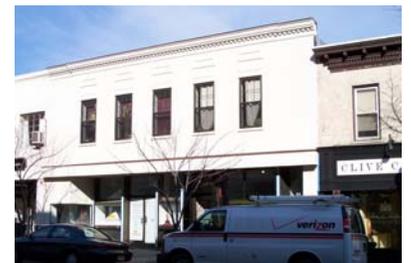
Recommended: Renovating substantially altered façades, such as this one, to be more compatible with the streetscape. Above shows building before Renovation; below shows after.

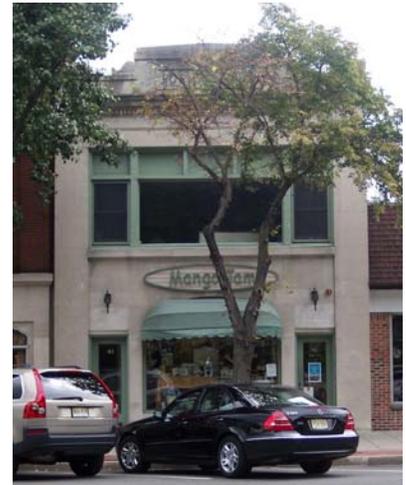
Recommended: Preserve historic facades and coordinate colors of exterior materials. The façade of 53 North Broad Street is a unified design with the 3-part composition of the upper window reflected at the storefront level. The window and door trim color is repeated in the awning and sign.

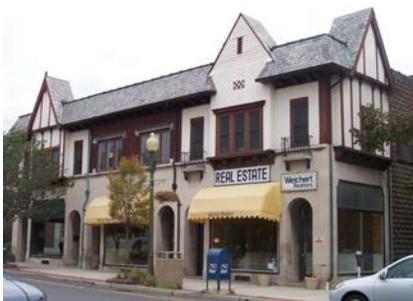
Recommended: Preserve little altered facades such as this one.

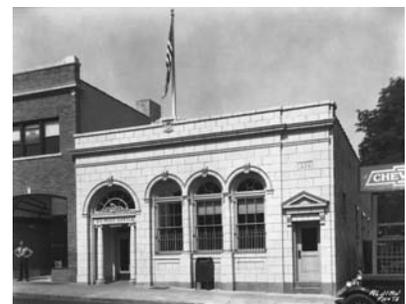
The Old Post Office Building at 36-38 Oak Street soon after it was built in 1929.

Recommended: Preserve little altered facades. Although the building has served many different functions- post office, municipal offices, newspaper offices, and now commercial use—its façade is very well preserved. It is a particularly elegant Renaissance Revival design interpreted in white terra cotta.
