# Storefront

## Guidelines

### For Contributing Historic Buildings

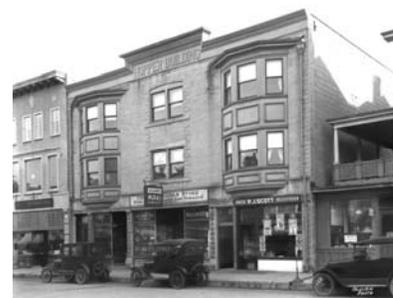
An example of an old photograph at the Ridgewood Public Library which is a valuable resource when planning a storefront renovation for a building shown or for a visually related building.

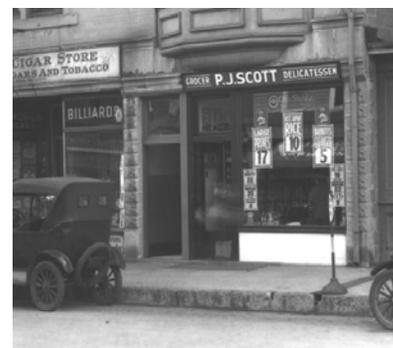
Detail from the above photograph showing one of the storefronts. In 1908 local photographer Aljian took this photograph of the Hopper Building at 28-32 East Ridgewood Avenue.

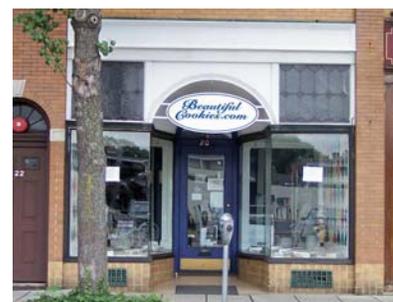
**Recommended: Preserve and repair little altered storefronts, such as this one.**

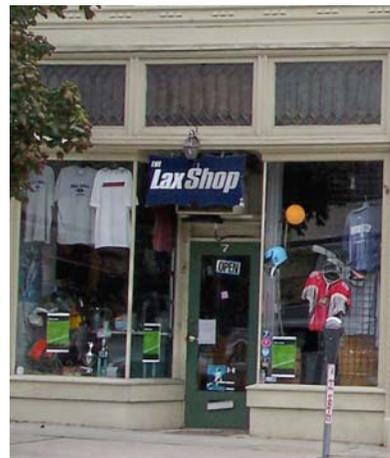
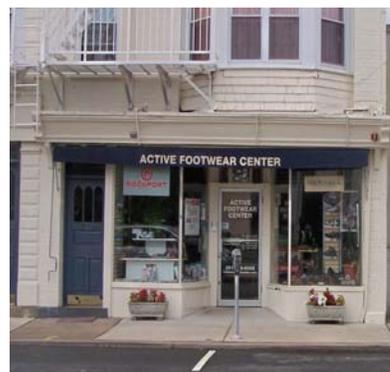
**Recommended: Preserve and repair little altered storefronts, such as these.**

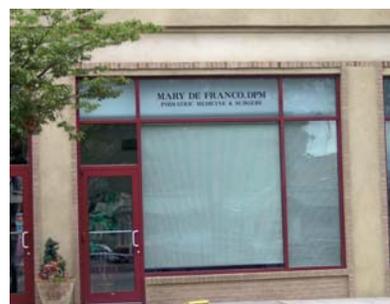
**Recommended: When the original storefront is gone, consider a compatible contemporary treatment.**

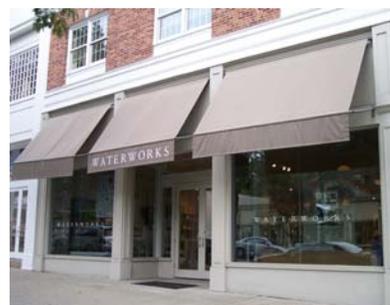
**Recommended: Storefront that fits the enframing and has a central recessed entrance.**

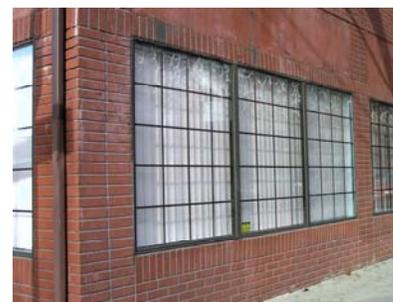
This new storefront has a sense of enframement and the 3-part division with bulkhead, large display window, and frieze. The division of the window into multiple panes would not be appropriate in most District locations.

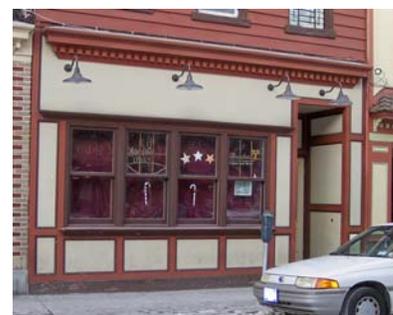
**Not Recommended: Use of double-hung windows instead of display windows.**

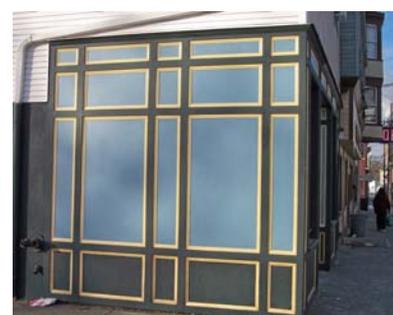
**Not Recommended: Blocking storefront windows.**

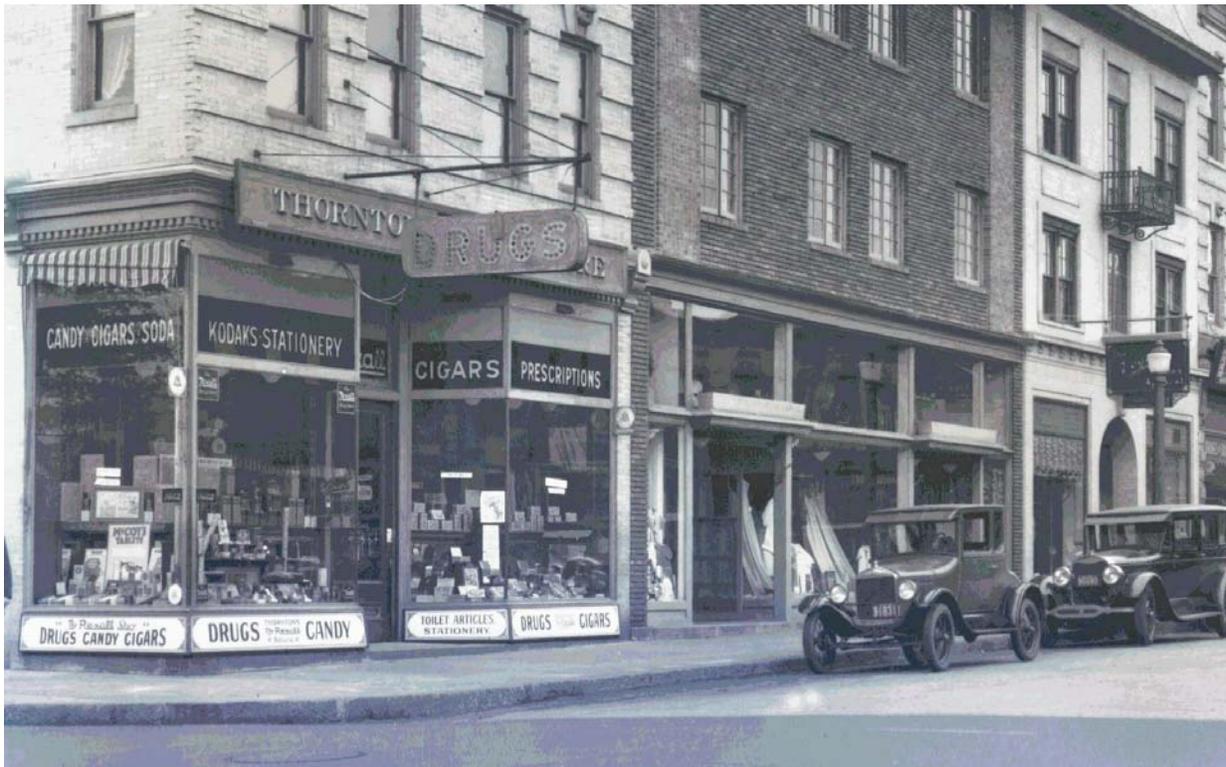
A detail from Aljian's photograph of the south side of East Ridgewood Avenue west of Van Neste Square clearly documents storefronts about 1927.
